Manhole Inspection Summary

Manhole # S21CC_047MH

Insp Date: **9/7/07 7:31 AM**

Location Address: **1620 WINCHESTER-RIGGS**

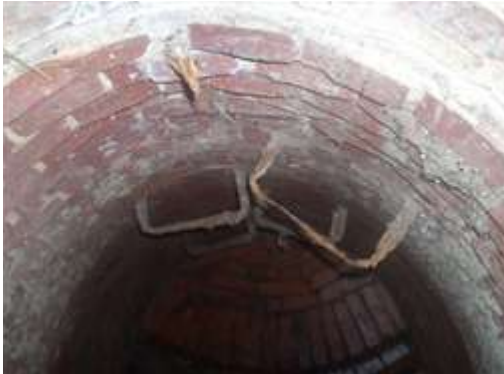
Defect 3

Count: **4** Missing: **1** ☒ **Corroded**

CORRODED AND MISSING STEPS

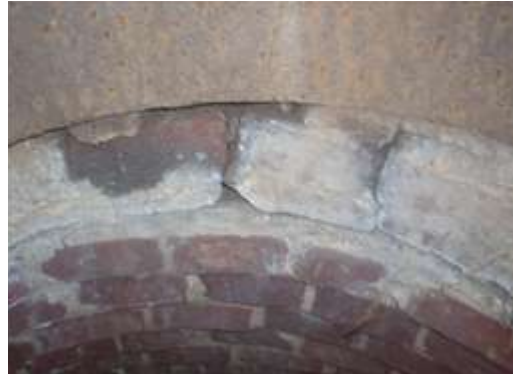
Defect 2

Condition: ☐ Sound ☒ **Cracked** ☐ Root Intrusion ☐ Loose Brick ☒ **Deteriorated**

Infiltration: ☐ None ☒ **Joint** ☐ Cracks ☐ Mortar ☐ Roots ☐ Wall

CRACKED AND DETERIORATED
CHIMNEY WITH INFILTRATION
EVIDENCE AT THE JOINT

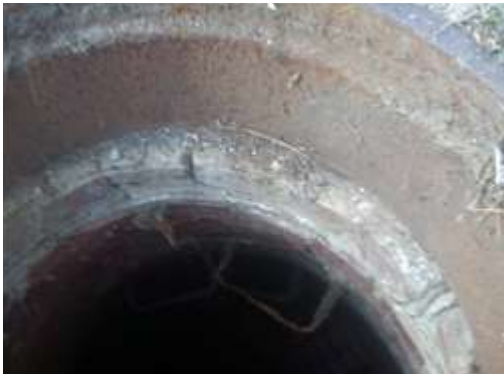
Defect 1

Offset: **2** (in.)

FRAME OFFSET

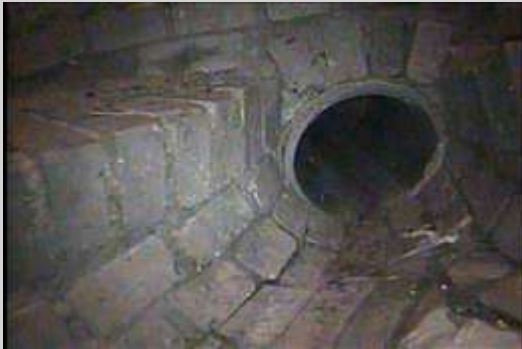
12 O'Clock Outflow

Pipe Height: **7.2** (in.) Rod and Bar (Angled)
Pipe Material: **Clay** ☐ Pipe Lined
Invert Depth: **8.93** (ft.) Flow Characteristics: **Slow**
Deposits: ☒ None ☐ Mud ☐ Sludge ☐ Debris ☐ Grease
Silt Depth: (in.) Deposits Extent:
Infiltration: **None** Pipe Seal Cond: **Sound**

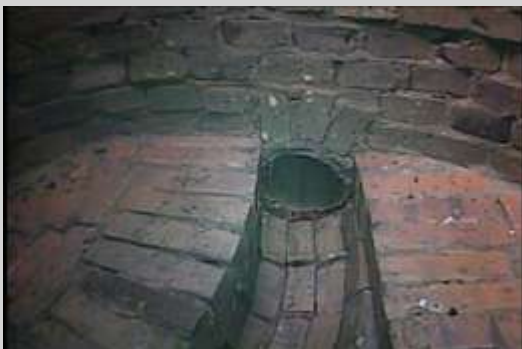
5 O'Clock Inflow

Pipe Height: **6** (in.) Rod and Bar (Angled)
Pipe Material: **Clay** ☐ Pipe Lined
Invert Depth: **7.94** (ft.) Flow Characteristics: **None**
Deposits: ☒ None ☐ Mud ☐ Sludge ☐ Debris ☐ Grease
Silt Depth: (in.) Deposits Extent:
Infiltration: **None** Pipe Seal Cond: **Sound**

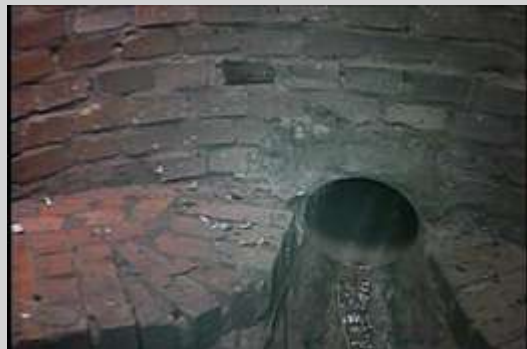
9 O'Clock Inflow

Pipe Height: **7.2** (in.) Rod and Bar (Angled)

Infiltration: **None** Pipe Seal Cond: **Sound**
